# Birgunj Metropolitan City

Secondary Towns Integrated Urban Environmental Improvement Project  
(STIUEIP)

# Report on July 2019 Flood

Prepared and submitted by Design and Supervision Consultant

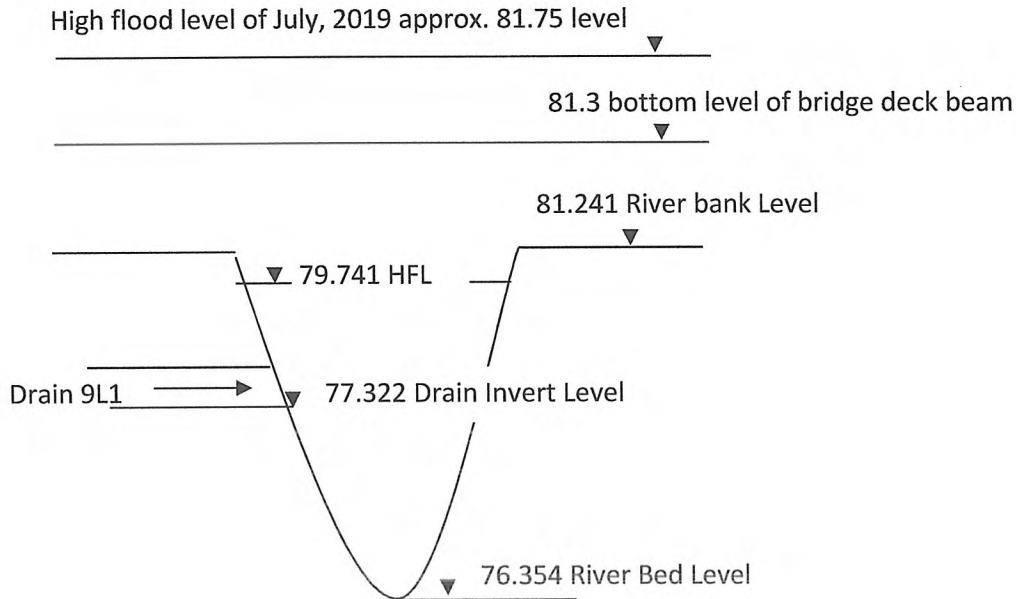
Bed level of Sirsiya river at outlet point of drain 9L1	: 76.354m
High Flood Level of Sirsiya river at outlet point of drain 9L1	: 79.741m
Level of river bank at outlet point of drain 9L1	: 81.241m
Invert level of outlet point of drain 9L1	: 77.322m
Dimension of drain 9L1 at outlet point to Sirsiya river	: 1.60m x 2.60m (HxB)
Invert level of junction point of drains 9 L1 and 9Lk	: 79.315m
Ground level at Kailash Hotel (lowest point)	: 81.00m

Cross Section of Sirsiya river at Outfall No. 9 (not in scale)

It is to be understood that the system has been designed for 2 year retention period and the HFL in the river has been calculated accordingly. The HFL of the river water is 79.741m which is about 0.426m higher than the invert level of the junction point. Even during the HFL, there is no chance of backflow of water from Sirsiya river through the junction point. During the years, when there is sever rainfall of higher intensity for longer duration, the water level in the river will goes much higher and even can overtop the river banks. In such a situation the drain will be defunct and even backflow from the drain may occur causing chances of inundation of the surrounding area.

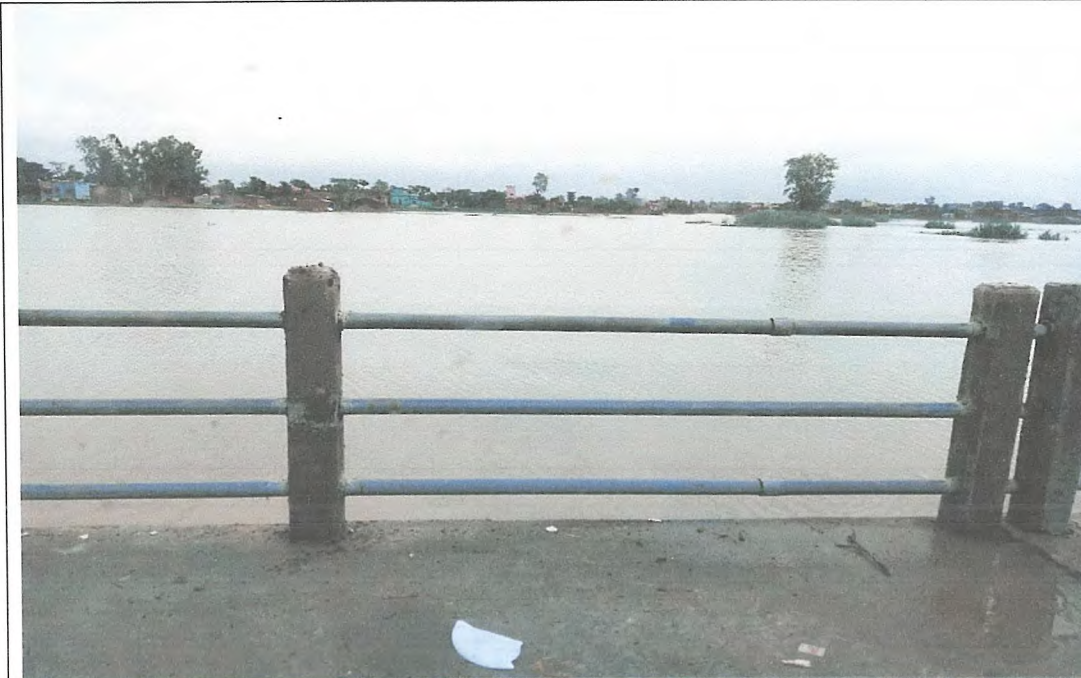
MD1 just disappeared beside STP

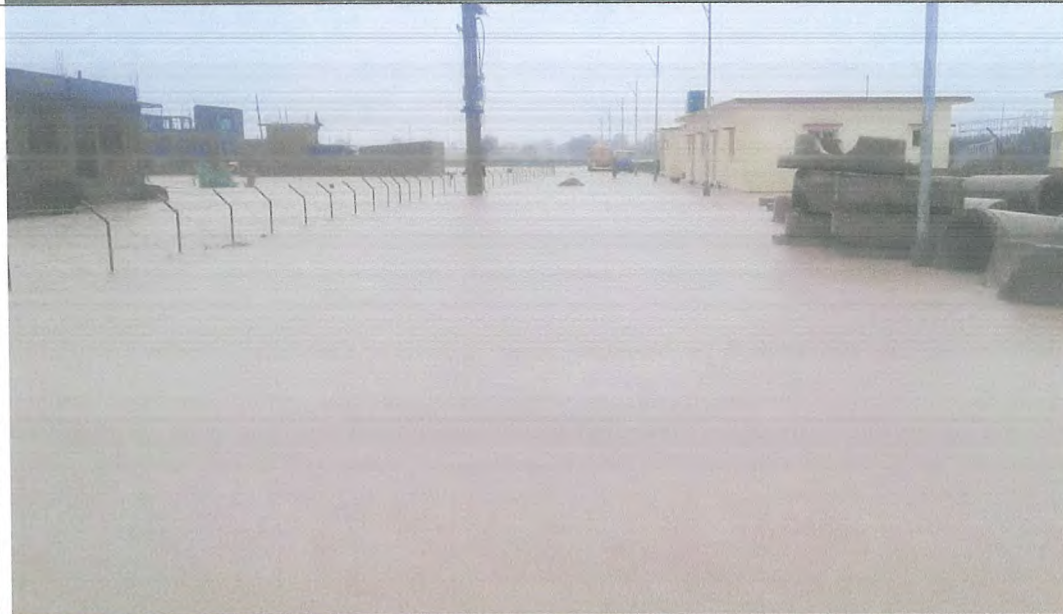
Water entered into lab building; ding inside STP behind the fence with wall is MD1

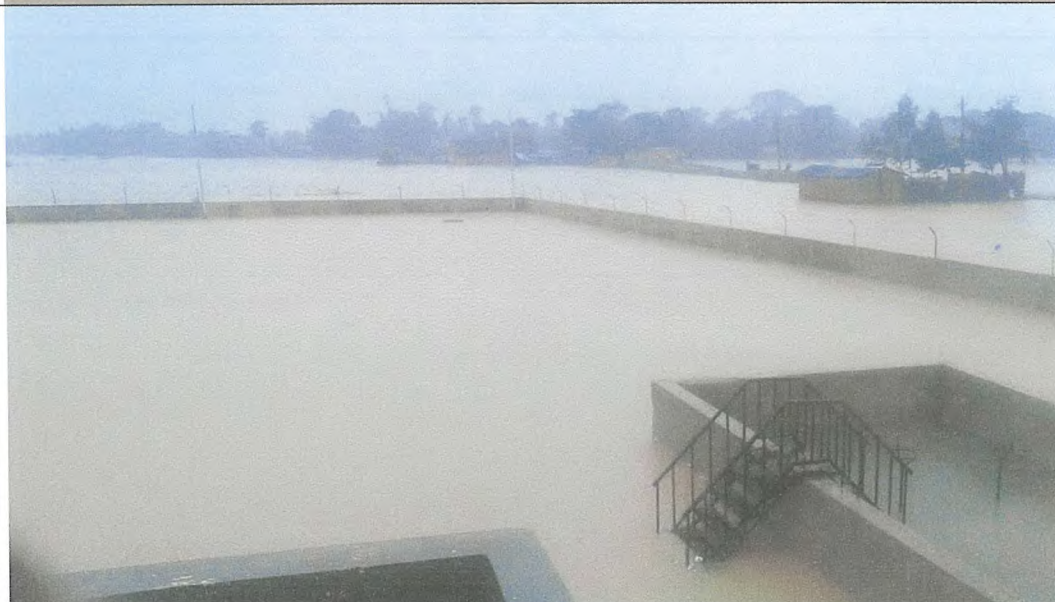
Water level raised more than half of 1.2 m high boundary wall inside STP

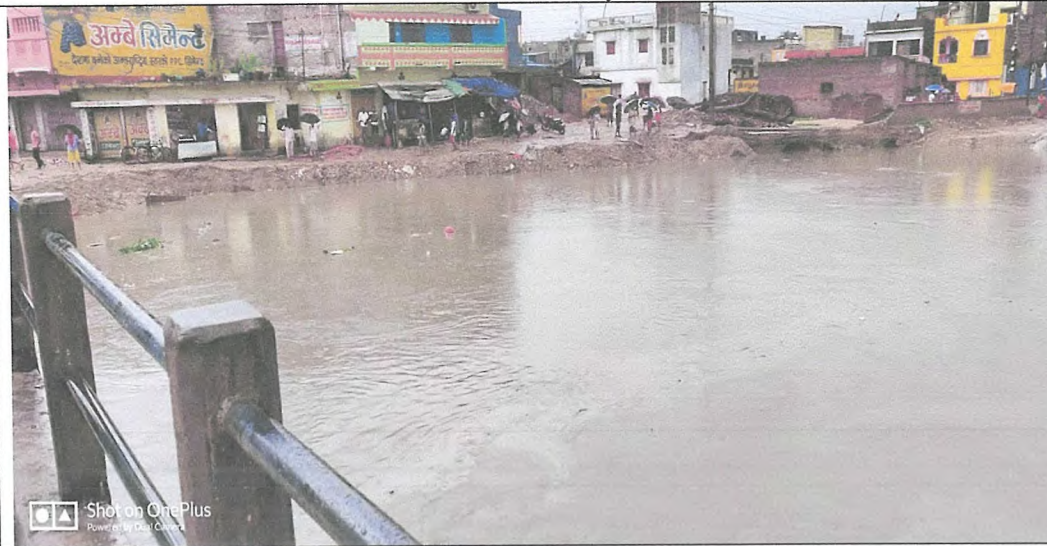
Subsiding  
Water level  
at Sirsiya  
after the  
end of rain

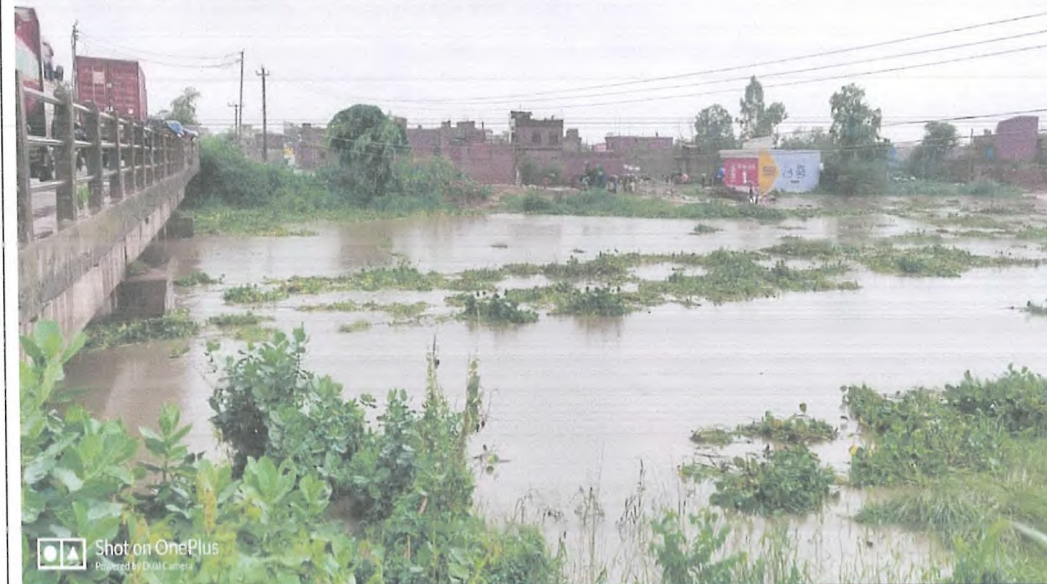
Subsiding  
Water level  
at Sirsiya  
after the  
end of rain

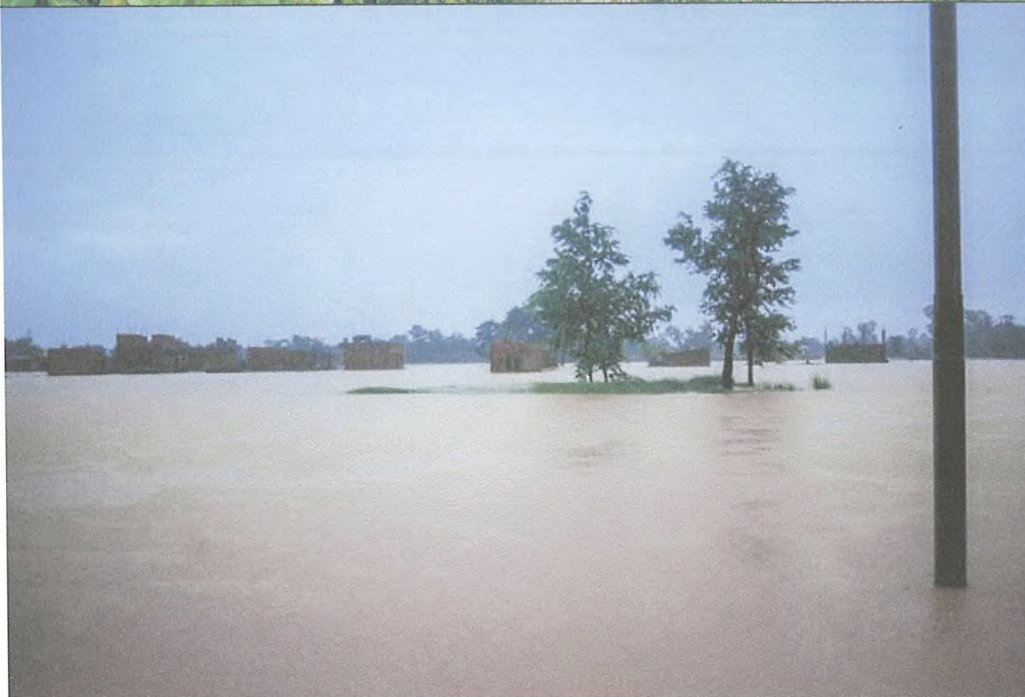
Sirsiya and  
surrounding  
area During  
the full flood

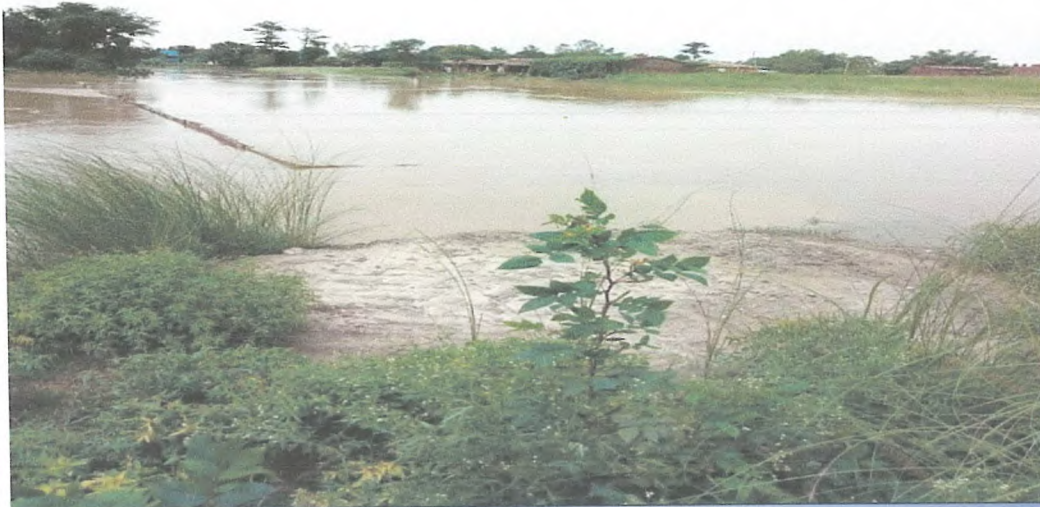
Subsiding  
Water level  
at Sirsiya  
after the end  
of rain down  
stream of  
Bridge

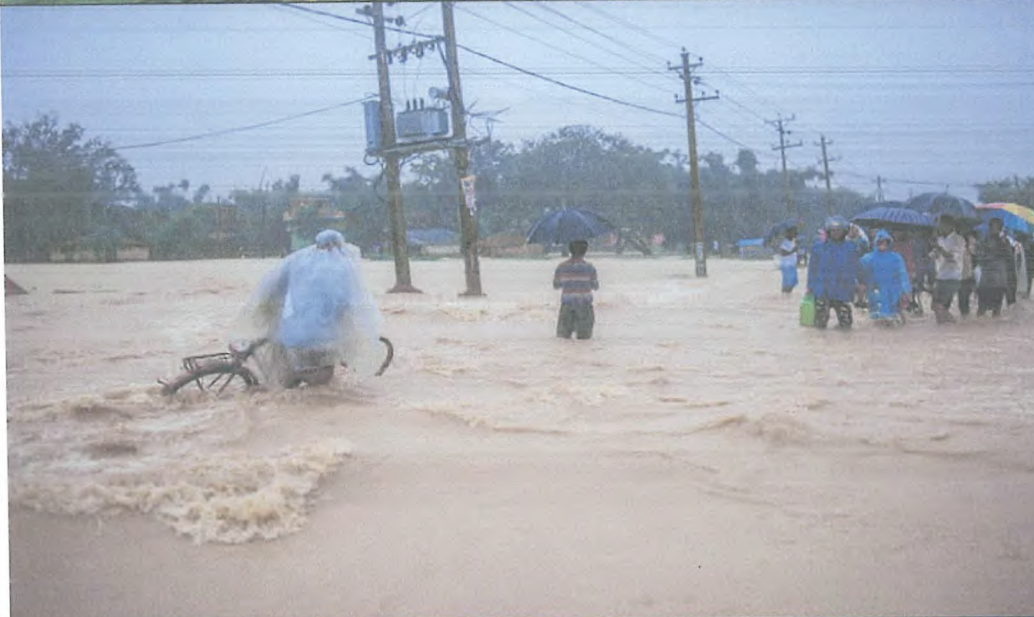
Padam  
Road near  
Sirsiya  
During the  
full flood

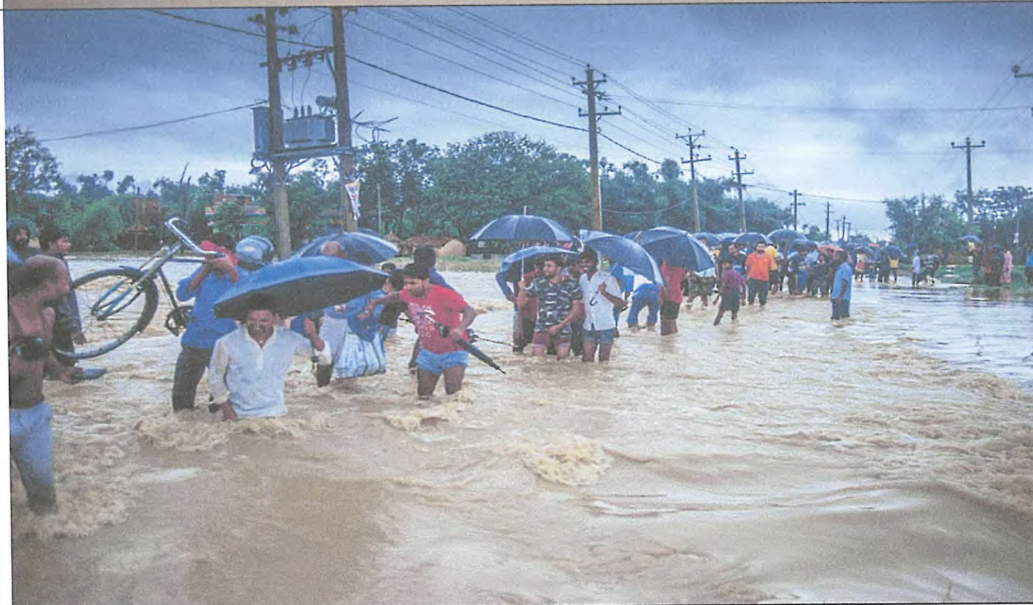
Padam  
Road near  
Sirsiya  
During the  
full flood  
people  
struggling  
to reach  
home

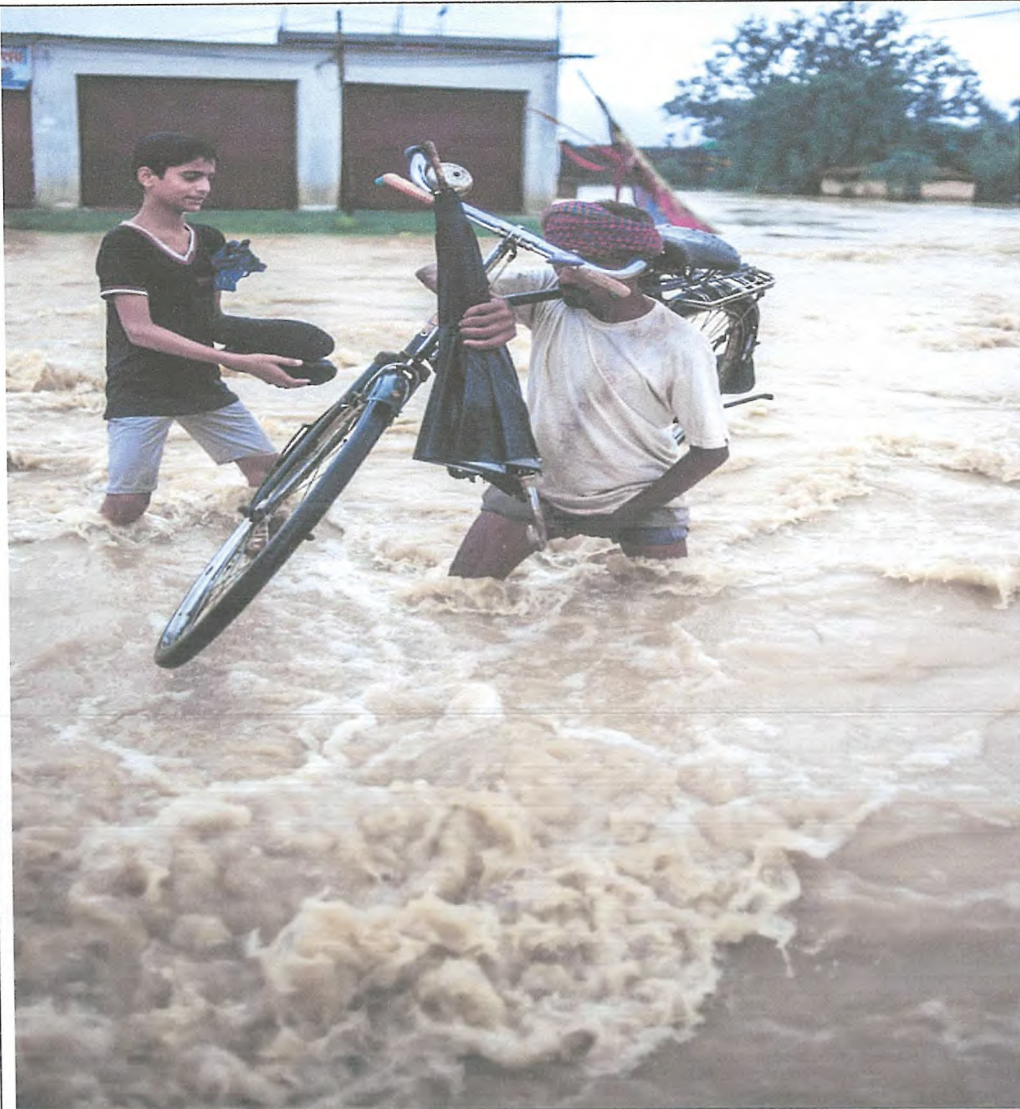
Padam  
Road near  
Sirsiya  
During the  
full flood  
people  
finding  
difficulties t

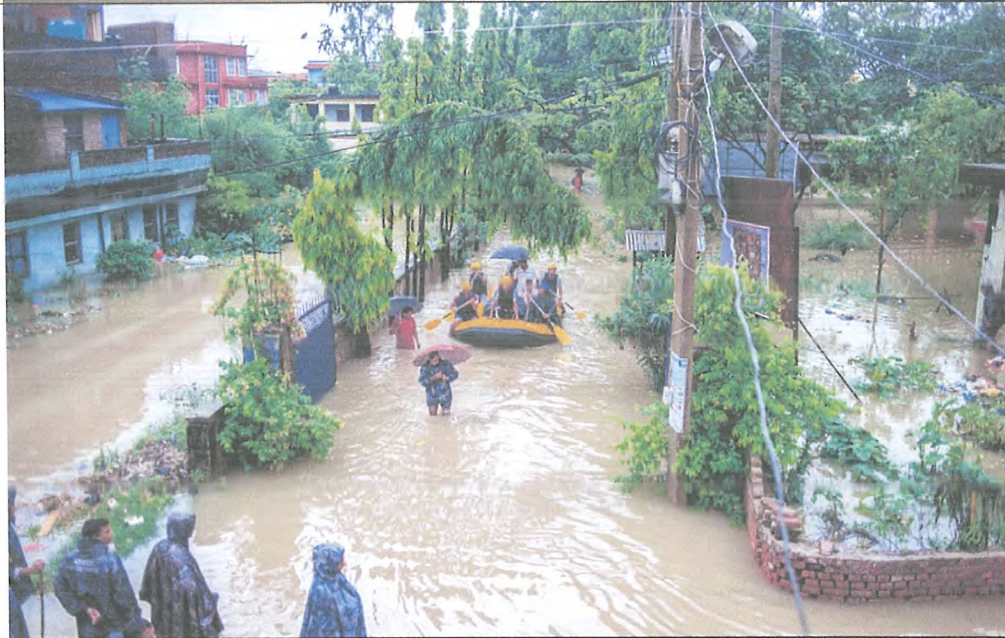
Chief district Office entrance besides MD1

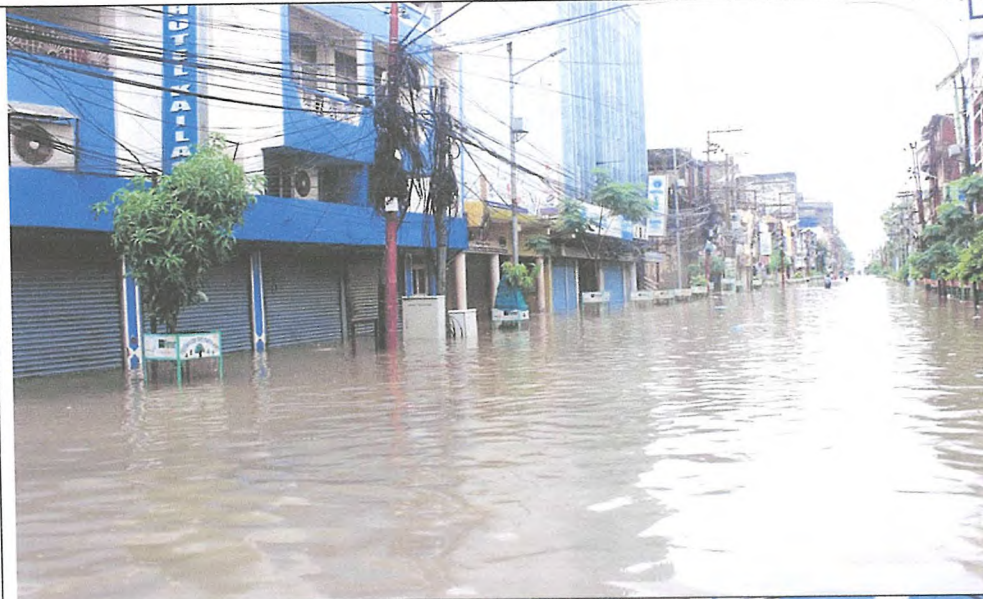
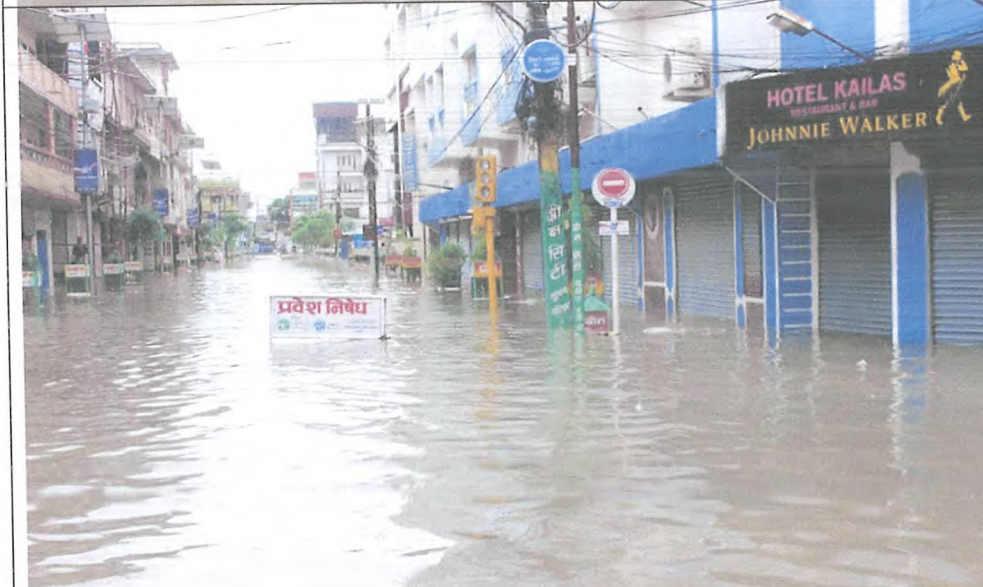
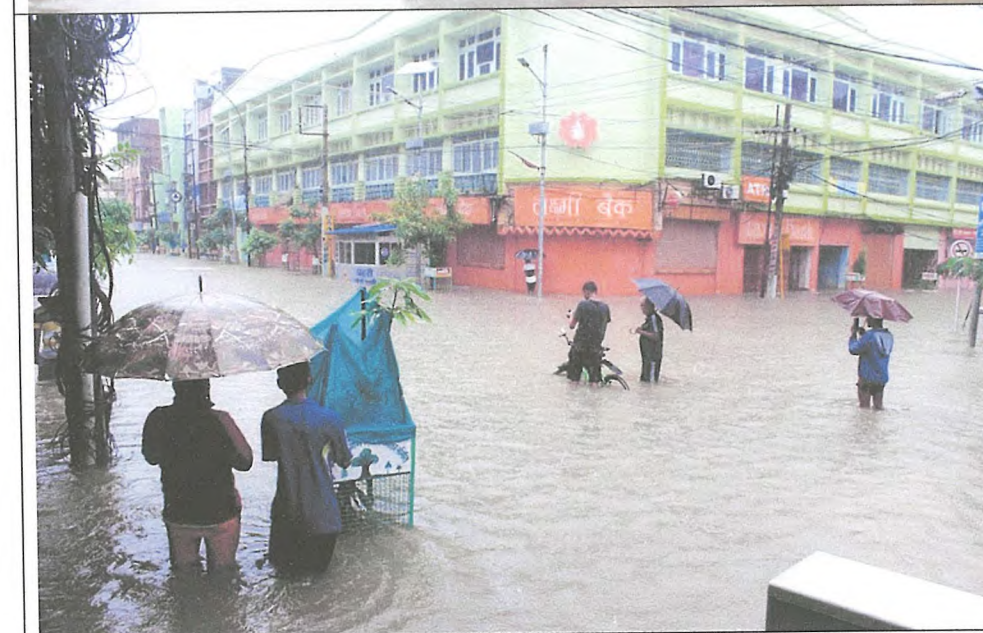
Lowest point  
at  
Adarshanagar

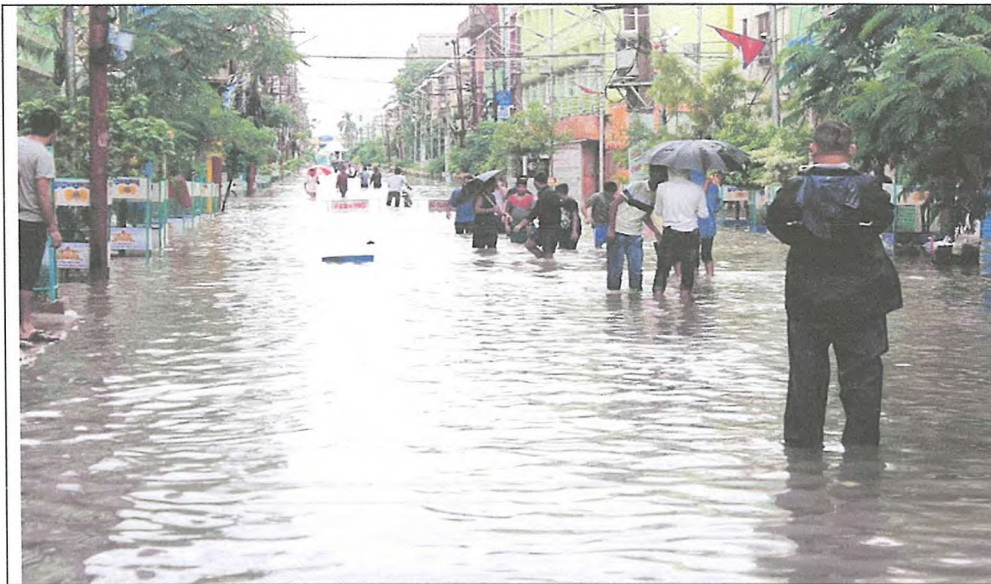
Other area at  
Adarshanagar

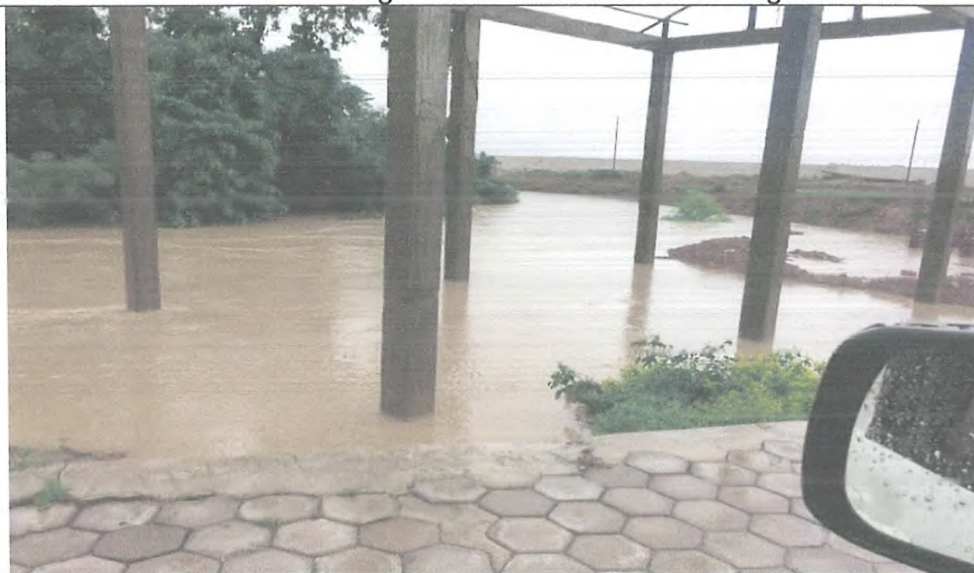
Singha River risen  
near to footpath  
level at  
Mashanghat

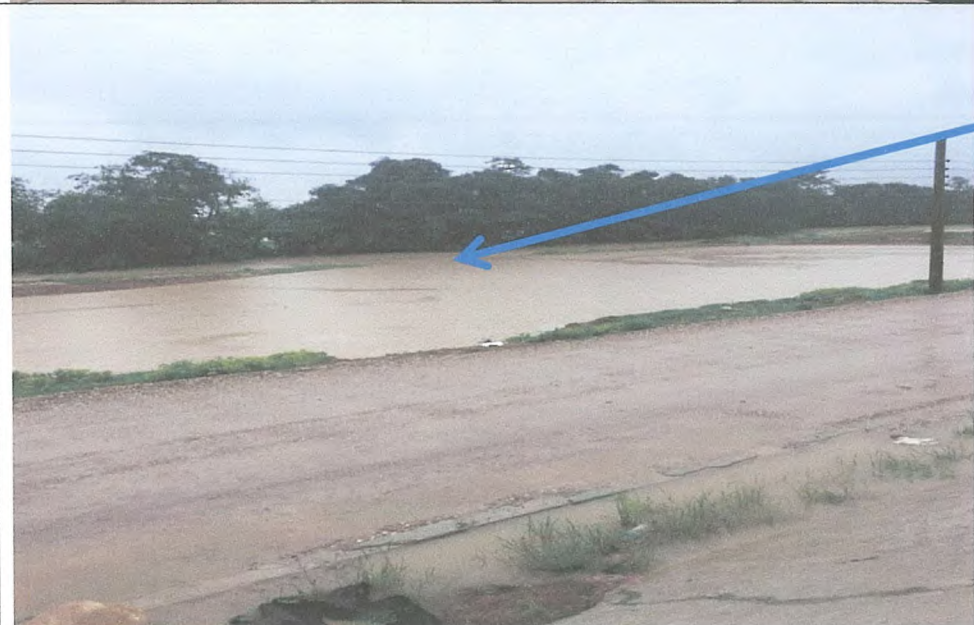
Singha River  
entered into  
Leachate  
Treatment

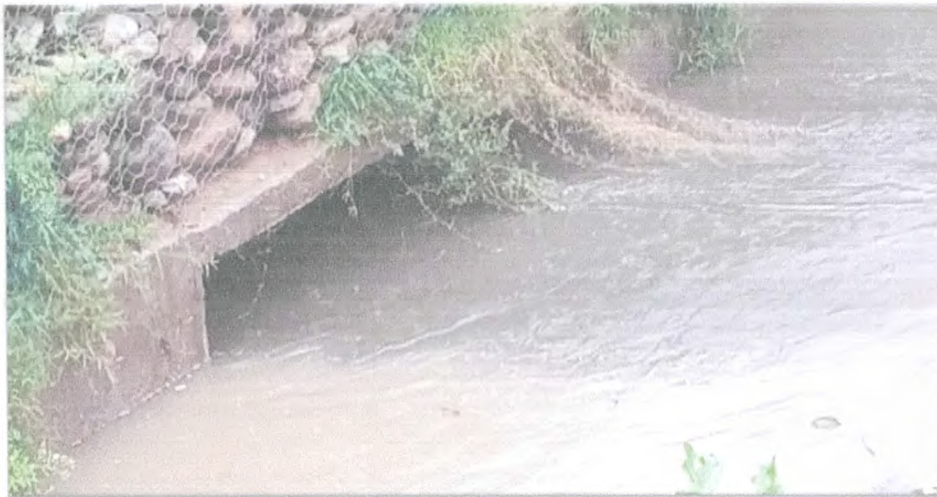
Stage-2 Overtopping and Plugging of Outfall-9 during rainfall

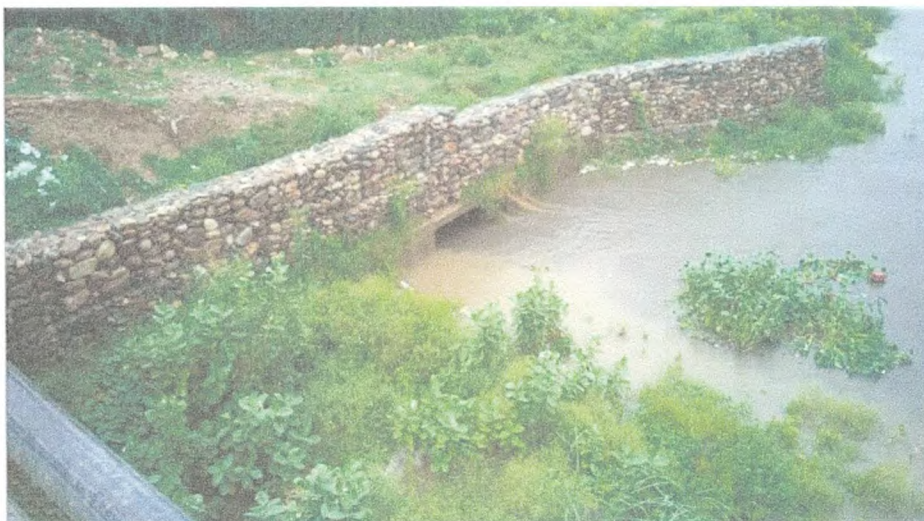
Stage-3 of Overtopping and Plugging of Outfall-9 during rainfall

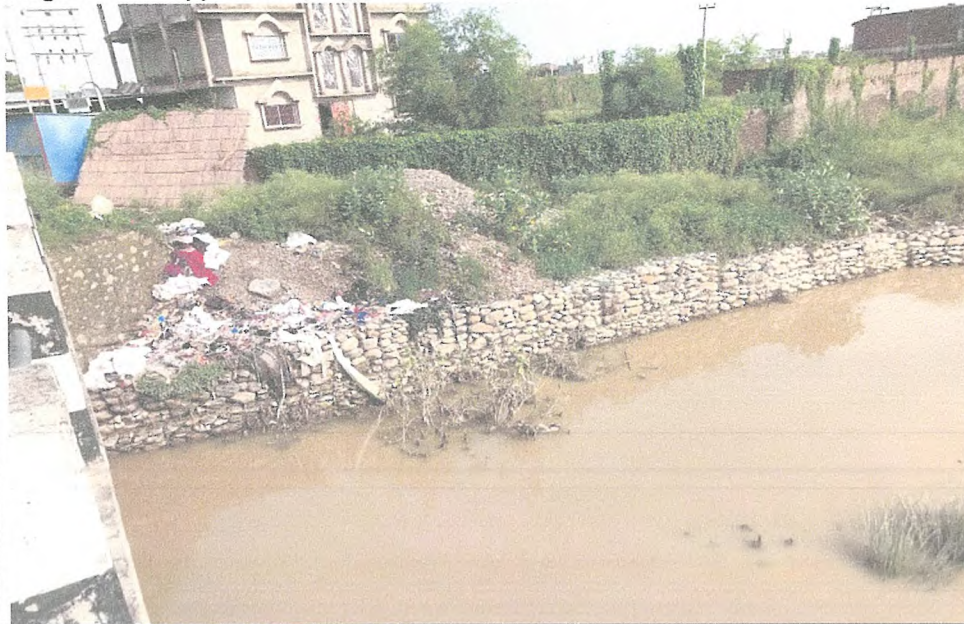
Stage-4 Overtopped and plugged Outfall no.-9

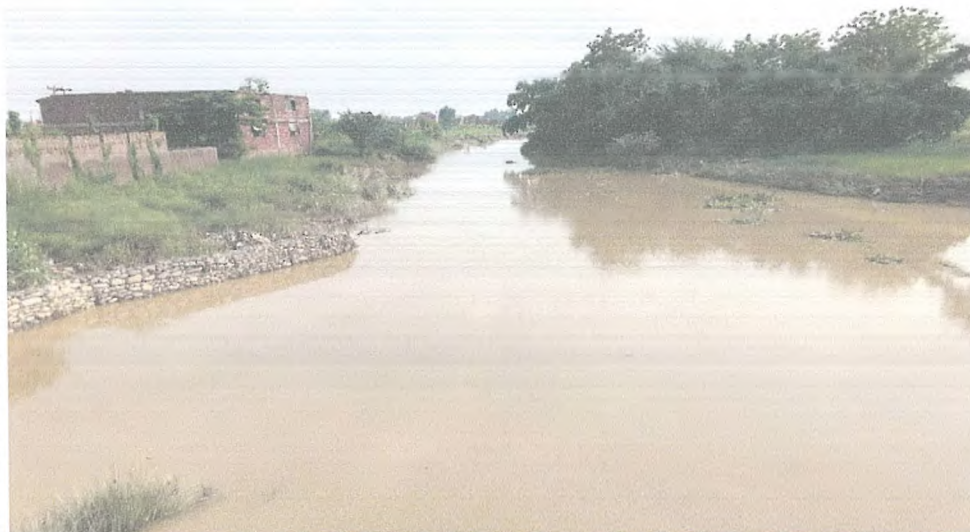
Stage-5 Sirsiya River course high flood level rising during rainfall

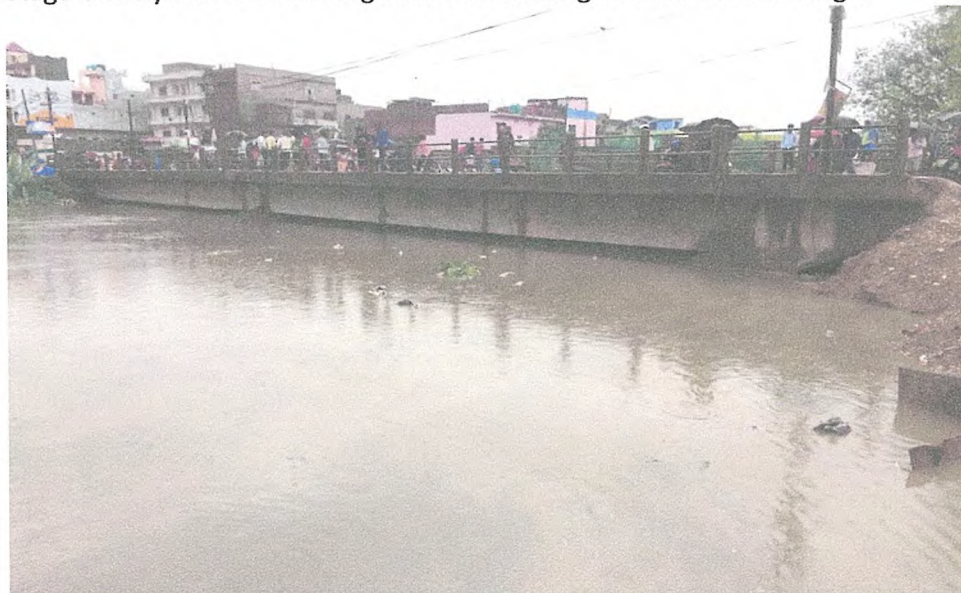
Stage-6 Sirsiya River course high flood level rising to deck level of bridge.

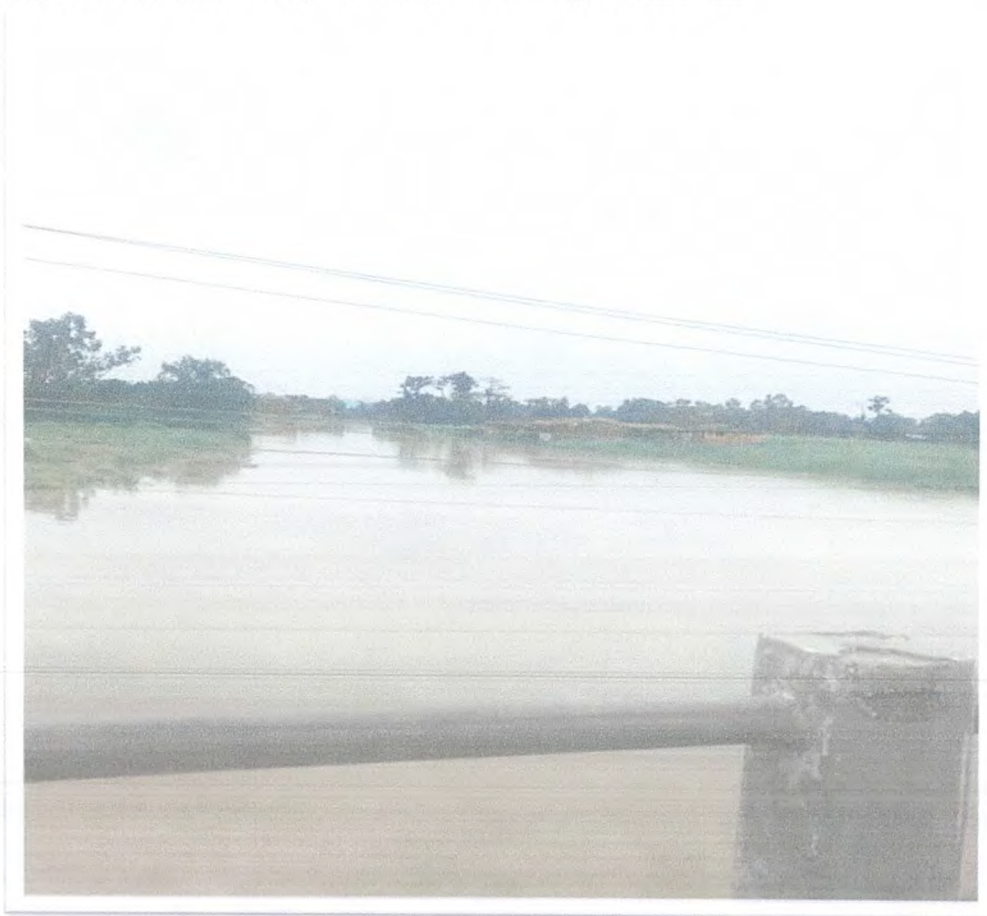
Stage-7 Sirsiya River bridge submerged due to high flood level.
